**Flood Control Project Maintenance
Levee Inspections**
LMA District Cover Sheet
Spring 2013 Levee Inspection Results

**Flood Control Project Maintenance
Levee Inspections
Unit Cover Sheet
Spring 2013 Levee Inspection Results
Plumas County**

Waterway				Bank	Unit Miles
Unit No. 01 North Fork Feather River				Left	1.89
	Spring (March - May)	Summer (June - August)	(September - November) Fall	Winter (December - February)	
Unit Maintenance Rating (Fall Only)					
Date of Inspection	04/24/2013 - 04/24/2013				
DWR Inspector	Bob Duffey				
Accompanied By	Jay Pettigrew Plumas County

Levee Inspection Report By Mile - Spring 2013

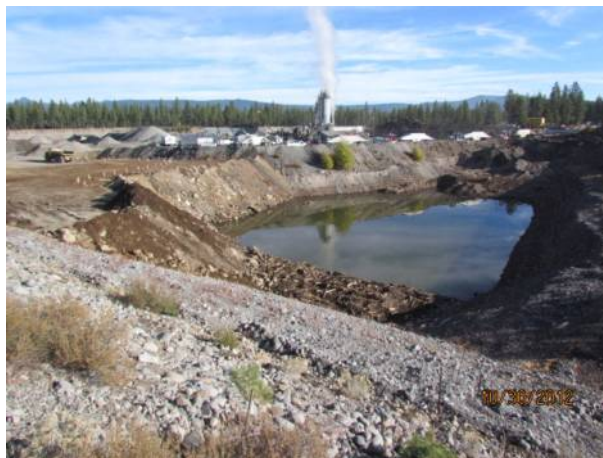
Levee Mile Report Line	6
Start Levee Mile	1.27
End Levee Mile	1.43
Location	Land Side
Category	
Item	Slope Stability

View of the landowner starting to fill in the hole at the gravel pit

40.279790 °	121.249850 °	Y
								DWR ID: DWR_NA0015_01_s_2012_9		
5	0.68	0.68		Encroachments	LS	M En	PR : Prunings	40.281480 °	40.281480 °	4
								-121.250928 °	-121.250928 °	Y
								DWR ID: DWR_NA0015_01_s_2013_4		
6	1.27	1.43		Slope Stability	LS	U Ma	S1 : Repair slope instability.	40.288780 °	121.254280 °	11

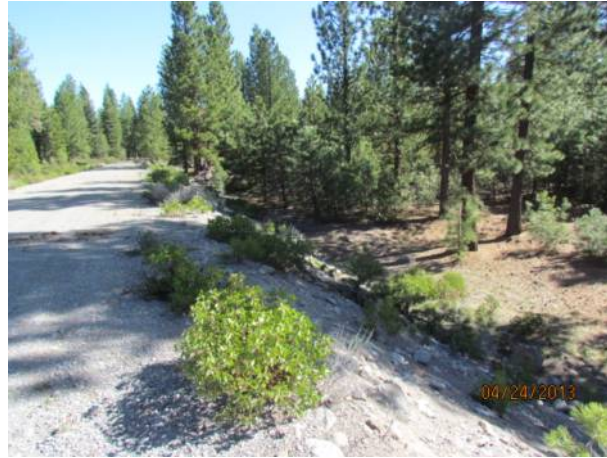
Levee Mile Report Line	7
Start Levee Mile	1.80
End Levee Mile	1.80
Location	Land Side
Category	
Item	Vegetation

View of the vegetation from both slopes.

40.290840 °	121.255440 °	Y
								DWR ID: DWR_NA0015_01_s_2012_11		
7	1.80	1.80		Vegetation	LS	M Ma	V1 : Control annual grass and weeds on the levee slopes and easements.	40.295972 °	40.295972 °	5
								-121.257485 °	-121.257485 °	Y
								DWR ID: DWR_NA0015_01_s_2013_5

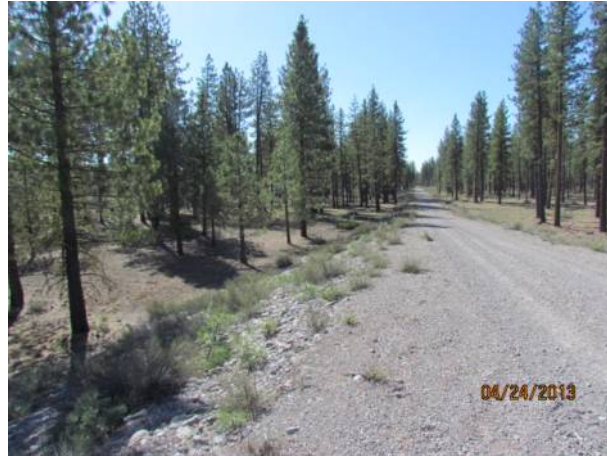
Levee Mile Report Line	1
Start Levee Mile	0.02
End Levee Mile	0.62
Location	Water Side
Category	
Item	Vegetation
View of the small pine trees that need to be removed from the waterside slopes.	
rduffey_s_20130429_388.JPG

LMR No.	Levee Mile		Category	Item	Location *	Rating **	Action/Comment	GPS Latitude/Longitude		Issue No. + Photo
	Start	End						Start	End	
1	0.02	0.62		Vegetation	WS	M Ma	V2 : Remove the wild growth other than native grasses from the levee slopes. Inspector Comments: Mow or remove the pine trees from the slope.	40.286415 ° -121.259613 °	40.281054 ° -121.252789 °	2 Y
DWR ID: DWR_NA0015_02_f_2012_2										
2	0.02	0.62		Vegetation	LS	M Ma	V2 : Remove the wild growth other than native grasses from the levee slopes. Inspector Comments: Mow or remove the pine trees from the slope.	40.286415 ° -121.259613 °	40.281053 ° -121.252792 °	1 Y
DWR ID: DWR_NA0015_02_f_2012_1										
3	0.46	0.46		Slope Stability	WS	M Ma	S2 : Repair the levee slope damaged by foot traffic and prevent access where possible.	40.282980 ° 40.282980 °	121.253990 ° 121.253990 °	3 Y
DWR ID: DWR_NA0015_02_s_2012_3										
4	0.55	0.55		Slope Stability	LS	M Ma	S3 : Repair the levee slope damaged by vehicle traffic and prevent access where possible.	40.281950 ° 40.281950 °	121.253710 ° 121.253710 °	4 Y

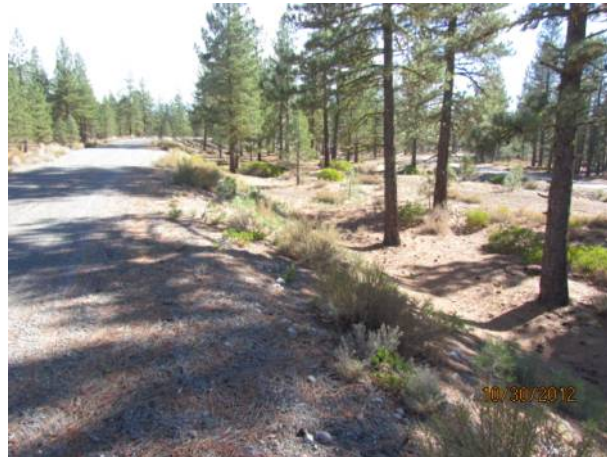
Levee Mile Report Line	2
Start Levee Mile	0.02
End Levee Mile	0.62
Location	Land Side
Category	
Item	Vegetation
View of the small pine trees that need to be removed from the landside slope.	
rduffey_s_20130225_148.JPG

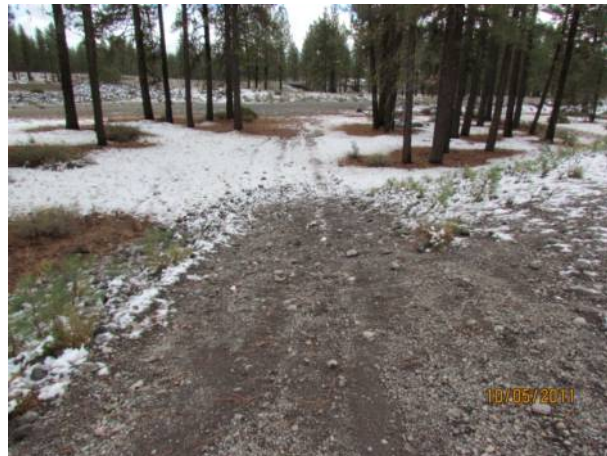
Levee Mile Report Line	3
Start Levee Mile	0.46
End Levee Mile	0.46
Location	Water Side
Category	
Item	Slope Stability
View of the vehicle erosion along the W/S slope.	
rduffey_s_20130225_150.jpg
